CASE STUDY: WALL REPLACEMENT

Due to excessive settlement as a result soft soils and age of the structure, the entire existing foundation of a farm home required rebuilding. The house was had sentimental value to the owner as it was built and passed down from his grandfather. The first story of the house had already been completely updated and restored by the homeowner. The entire project included excavation, temporary shoring, replacing all four concrete basement walls, waterproofing system installation, beam installation with new footing pads, and pouring and finishing new concrete flooring.

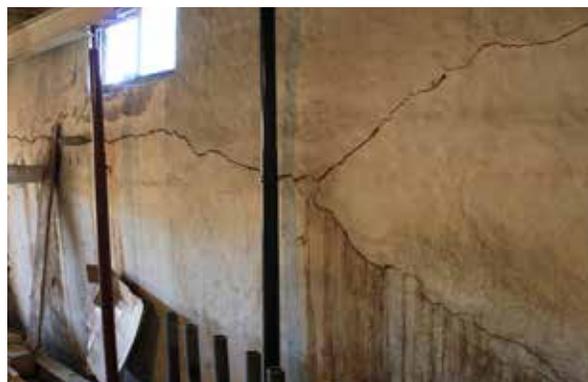
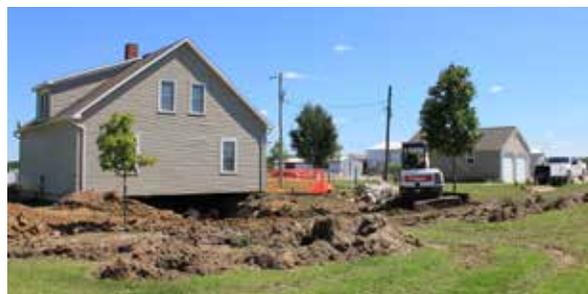
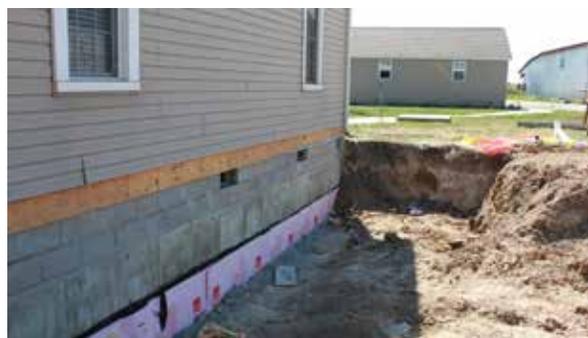
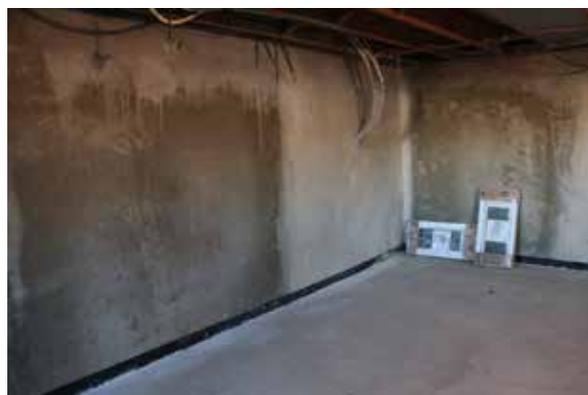
When the additional support beams were added, it was discovered that some of the wood had rotted and needed replaced. During initial inspections, it was discovered that some of the wood beams had rotted and needed replaced. To fully support the structure, 30 feet of rim joist was installed on an external wall to replace a rotted section of the band board. We also needed to add six, 2x8" floor joists for additional support as the existing had been damaged by termites.

JOIST INSTALLATION During initial inspections, it was discovered that some of the wood beams had rotted and needed replaced. To fully support the structure, 30 feet of rim joist was installed on an external wall to replace a rotted section of the band board. We also needed to add six, 2x8" floor joists for additional support as the existing had been damaged by termites.
